Experimental Investigations into Accidents of Two Japanese Fishing Vessels

135GT PURSE SEINER ACCIDENT

113GT STERN TRAWLER ACCIDENT

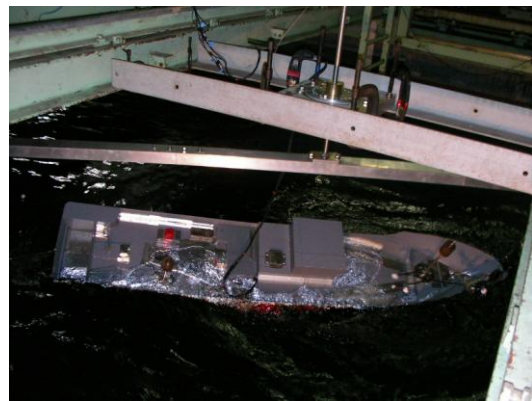
Fig. 1: Model Ship in Waves.

In the experiment a 1/23.9 scaled model ship was moored to the carriage with weak springs to simulate the situation of lying to with a sea anchor and keep intended encounter angle in waves and ship motions were measured in starboard bow to beam waves (Fig. 1). In the experiment wave conditions (properties and encounter angle) and ship conditions (position of centre of gravity and function of freeing ports) were varied and their effects on capsizing were investigated.

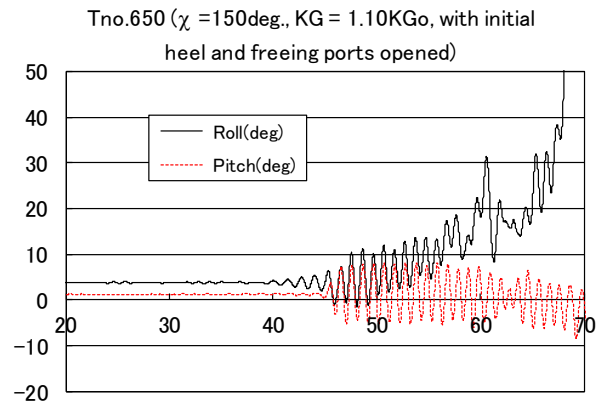
Fig. 2: Measured roll angle and pitch angle in regular wave of $\lambda = 1.6m$ and $H_w = 0.13m$ with a superimposed concentrating wave. $\chi = 150$ deg., $KG = 1.10KGo$ and with initial heel and all freeing ports opened.

Fig. 2 shows typical time histories of roll angle and pitch angle in capsized case. From the measured ship motion and the observation during the experiment the capsizing sequence in bow waves could be summarised as follows (refer to Fig. 2). At first shipping water around midship part occurs and water floods the fore deck. This increases the bow trim and the starboard heel and the resultant freeboard around the starboard bow section decreases. This change in the mean position of the ship stimulates further shipping water. At last successive shipping water occurs and the increased flooded water reduces the stability of the ship, then the wave action turns over the ship. In short, the mechanism of the capsizing

in bow waves is that the increased flooded water on the fore deck reduces the freeboard of bow part and the reduced freeboard accelerates shipping water then with the increased flooded water stability of the ship reduces drastically and capsizing occurs.

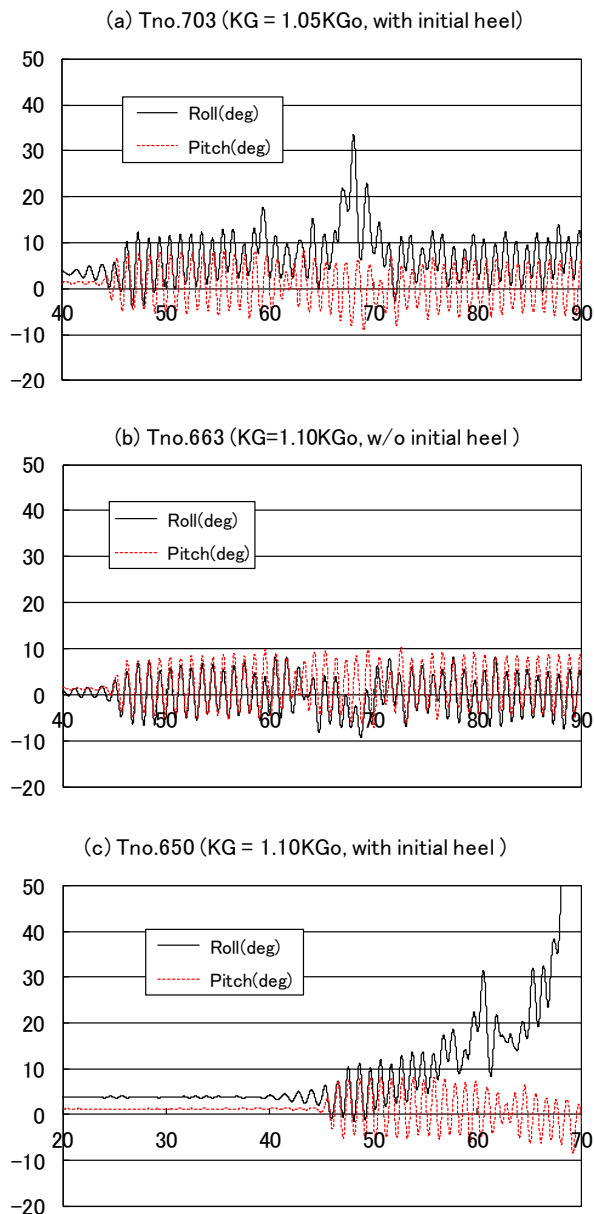
Fig. 3: Effects of height and lateral deviation of C.G. on measured roll angle and pitch angle in regular wave of $\square = 1.6\text{m}$ and $H_w = 0.13\text{m}$ with a superimposed concentrating wave. $\square = 150\text{deg.}$ and with all freeing ports opened.

which have been clarified in the experiment, it is presumed that following factors, increased height and lateral deviation of C.G., poor function of freeing ports and improper encounter angle to waves played key roll to the capsizing of the purse seiner.

On the other hand the experimental result shows that no capsizing occurred with the encounter angle of 165 degrees and even in the highest C.G. condition capsizing did not occur with no lateral deviation of C.G. and all freeing ports opened (Table 4 and Fig. 3).

These experimental results imply that careful operation and sufficient maintenance of vessels with the above things into consideration might prevent similar accident.

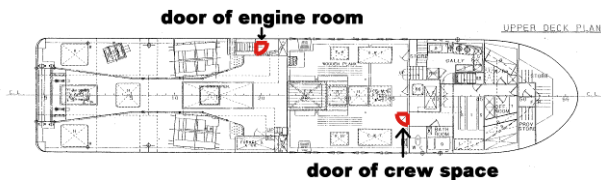
Fig. 4: Opened watertight doors.

minutes later, she was lost from the radar of the consort trawler. The foundered trawler was salvaged to investigate conditions and damages. There was no serious damage of hull and some water tight doors were opened.

The subject ship model used in this research is the 1/16 scaled. The principal particulars are shown in Table 5. According to the investigation of salvaged trawler, two watertight doors were opened. Opened doors are shown in Fig. 4. For recording shipping water and flowing point, the model ship was installed with 5 video cameras and 360 degrees video camera. The positions of cameras are shown in Fig. 5. The 360 degrees camera recorded situation in the working room as shown in Fig. 6.

by state so that prompt attitude adjustment is possible so as to prevent water from flooding in. And for "Stern trawler Yamada-maru No.2 accident", the remarks require that during navigation, exit doors etc. on the deck should always be closed and whenever they are opened for access, they should be closed promptly.

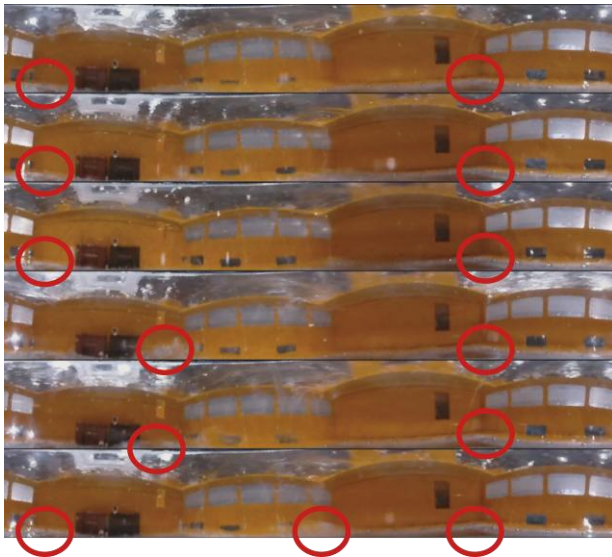
Fig. 7: Flooding water in the working room (red circle) observed with wave period = 6 sec, wave height = 5.88m, $\chi = 28$ degrees. (interval = 0.8sec; time goes on from top to bottom)

An example of flooded water in the working room at "huge flooded water on deck" case is shown in Fig. 7 and the time series of ship motion and rudder angle in the same condition are shown in Fig. 8. The average heel angle of

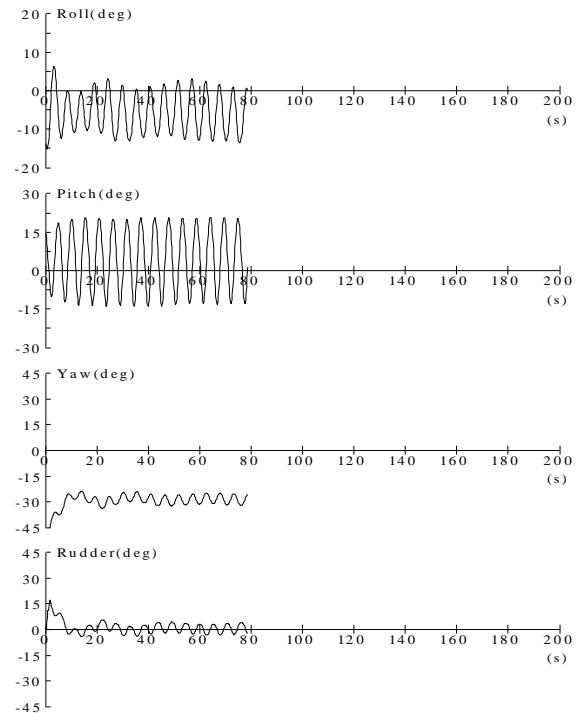
Fig. 8: Time series. (wave period = 6 sec, wave height = 5.88m, $\chi = 28$ degrees)

water on deck was -7 degrees in this case. But Fig. 8 shows that the flooded water in the working room had never reached to the door of crew space.

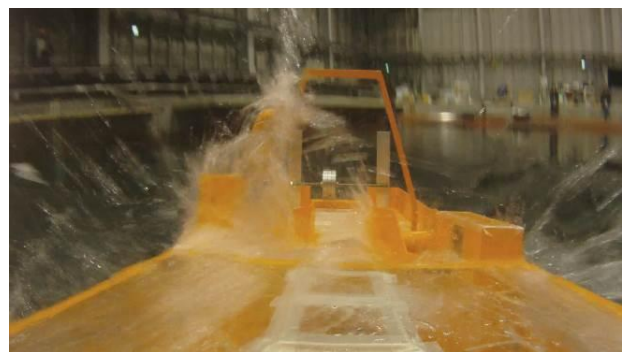
Fig. 9: Shipping water on upper deck

Fig. 9 shows the shipping water on upper deck. It shows that the shipping water from bow went straight to the opening entrance of engine room.

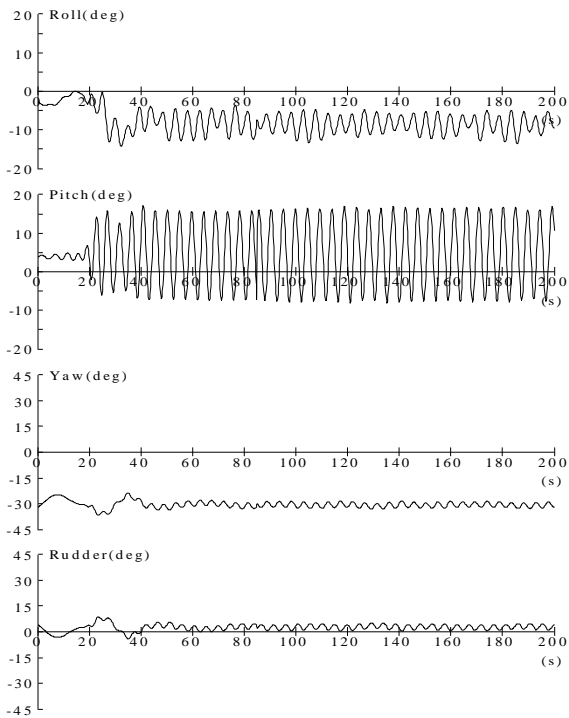
Fig. 11: Time series. (wave period = 5.5 sec, wave height = 1.94 m, $\chi = 28$ degrees)

Time series with 12 t of flooded water is shown in Fig. 11. 1.94 m wave height is enough to make initial roll angle to the situation of water on deck.

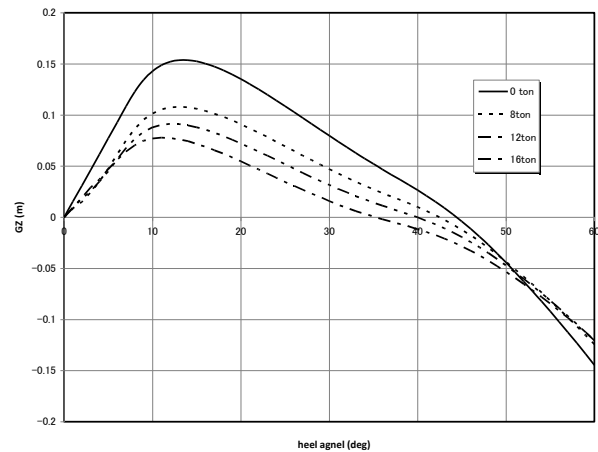
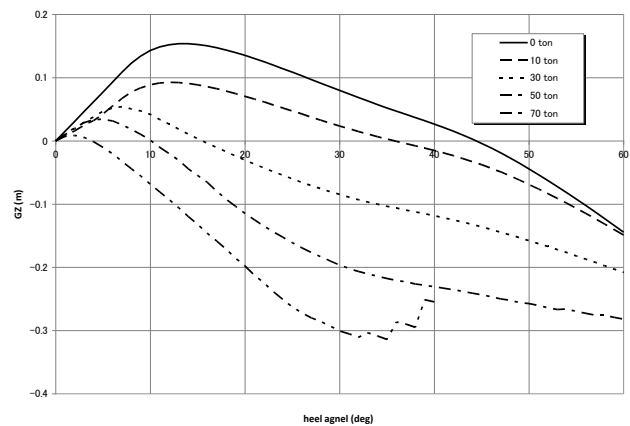
Stability curve with flooding water in engine room is shown in Figures 12 and 13. It shows that maximum GZ is reduced by 30% with 12 t of flooded water and by 50% with 16 t of flooded water. And, there is no stability left with 70 t of flooded water.

Stability calculations show that more than 70 t of flooded water in the engine room makes

total loss of stability. Based on the estimated flowing rate of water into the engine room, 2 minutes is enough time for flowing water of 70 t into the engine room. Reserve buoyancy of this trawler is about 202.7t. Less than 5 minutes is enough to sink it.
