INVESTIGATION INTO THE SINKING OF THE RO-RO PASSENGER FERRY *EXPRESS SAMINA*

A. Papanikolaou, D. Spanos, E. Boulougouris, E. Eliopoulou, A. Alissafaki
National Technical University of Athens-Ship Design Laboratory, NTUA-SDL, (Greece)

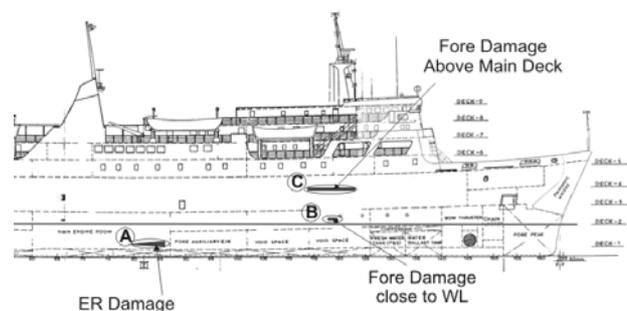
The sideways collision of the ship with the rocky islet created three main damage openings on the ship's starboard outer shell, as described in the appointed divers' investigation reports. As illustrated in the next Figure 3 the first one, denoted by letter A, is located in the main engine room's bilge area, around frame 85, just aft of the starboard stabilizer fin chest. It resulted from the shell penetration by the fin as it moved backwards after the fin collided with the rocks, see Figure 4. The damage is limited to one compartment, namely that of the main engine room, extending from the fore bulkhead of the main engine room and backwards for about 3m. This damage is obviously the dominant opening that determined the flooding procedure of this ferry accident.

Figure 3 The damage openings

The second damage, denoted as B in Figure 3, is actually a set of three cracks located at about a quarter length from the bow and at the height of ship's waterline on starboard side. The cracks are strip wise shaped openings with the largest one about 60 cm in length. These damages are considered of secondary importance for the accidental outcome, as their size and location close to waterline permitted only limited inflow rates compared to the other openings.

The third damage opening, denoted as C, is a typical raking damage and the largest one observed. It is practically located above damage B at the height of the platform deck on ship's starboard side. Its size could not be exactly determined, as the shipwreck, laying on a sandy seafloor, is partly covering this opening. Based on the divers' reports and testimonies of the crew, its extent is estimated to be about 6.0 m in length and up to 1 m wide.

Damage C (and the minor cracks B) can be regarded as the first damages created on ship's outer shell following the non-successful collision avoidance maneuvers by the bridge officer. Moments later, as the ship kept moving, the unfolded starboard stabilizer fin collided on the rocks and moved backwards penetrating the main engine room's bilge area and creating the major damage A.

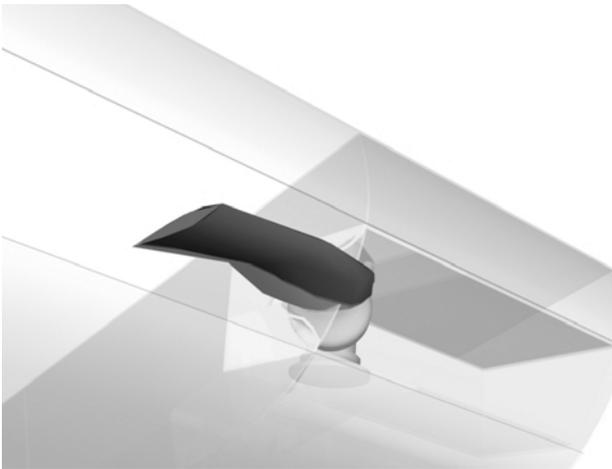
Figure 4 The starboard stabilizer fin penetrating the ship's main engine room

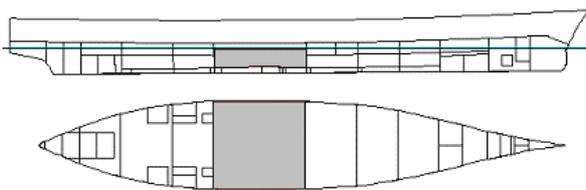
Considering, first, that flooding due the incurred damages was limited within the extents of the Main Engine Room, the ship proved satisfactory in terms of reserve buoyancy and relevant stability criteria to withstand the particular flooding.

Figure 6 One flooded compartment scenario

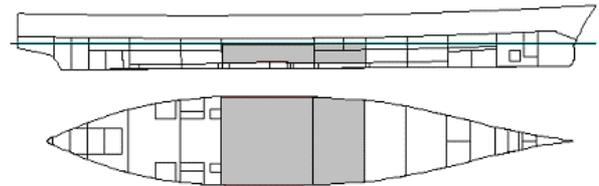
Considering the watertight door, connecting the main engine room with the forward auxiliary engine room, open¹², the resulting scenario of flooding leads to flooding of two

compartments, namely that of the main engine room and of the forward auxiliary engine room. Though the ship was actually registered as one compartment ship, it proved that for the particular loading condition the ship could survive this damage as well.

Figure 7 Two flooded compartments scenario: main and forward auxiliary engine room

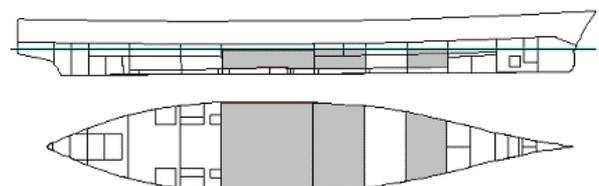
Figure 8 describes a further hypothetical flooding scenario taken into account the described hull damages A and B, as well as the watertight door between main and forward auxiliary engine room, to be open. According to performed calculations, although in this case the bulkhead deck line immerses at the equilibrium position, the ship would have adequate reserve buoyancy and stability, Figure 9, to avert further progressive flooding. In addition, there was adequate margin of heel to avoid an immersion of the damage opening located above water, at ship's platform deck [Damage Opening C].

Figure 8 Three flooded compartment scenario

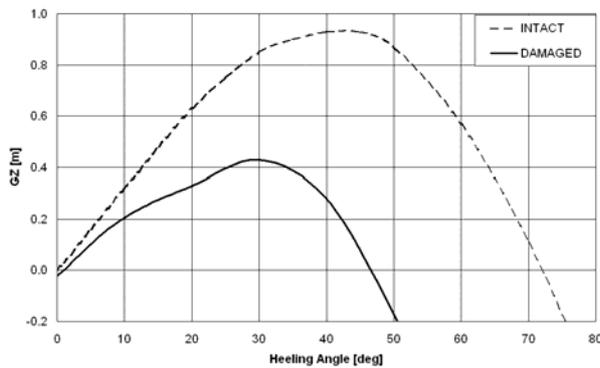
Figure 9 GZ curve for the three flooded compartments case

The above results clearly suggest that if the ship's watertight doors (especially: those of the main engine room) were closed, the ship would most likely have survived the incurred damages or in the worst case she would have sunk after a prolonged time allowing safe evacuation.

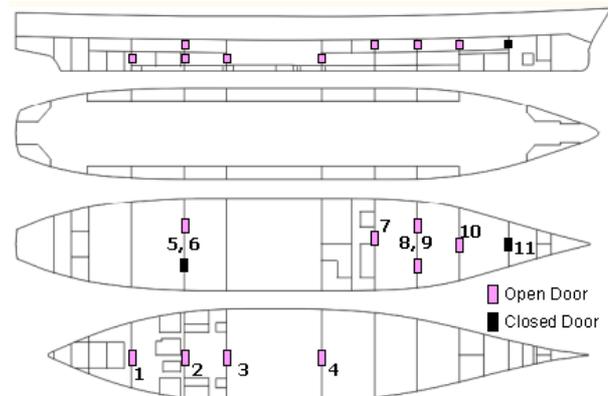
Figure 10 Condition of watertight doors

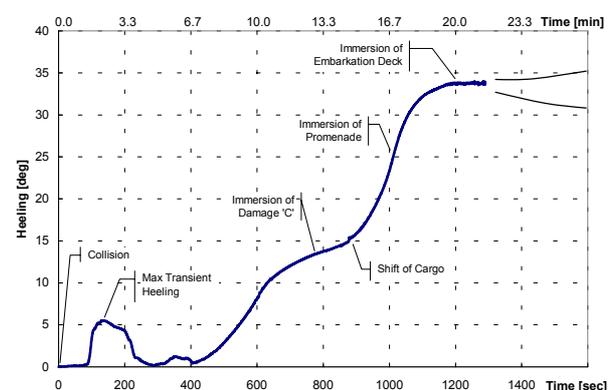
The results of the numerical simulation for ship's heel angle after damage, assuming the most probable flooding scenario (9 out of 11 WT doors open) are shown Figure 11. Shortly after damage, the ship obtains for short time a transient heel to starboard of about 5 degrees and then goes back to upright, before gradually obtaining large heel angles to starboard, reaching more than 30 degrees merely twenty minutes after the collision.

Figure 11 Simulated heeling for the most probable flooding scenario

Commenting on the ship's heeling behavior depicted in Figure 11, the transient heeling angle of about 5 degrees experienced in the first 4 minutes after collision was noted by the passengers, who felt for short time relieved as the ship came back to upright. The simulation analysis showed that this heeling angle is a transient free-surface effect of the floodwater poured into the main engine room, before spreading and flooding the whole engine room and adjacent compartments.

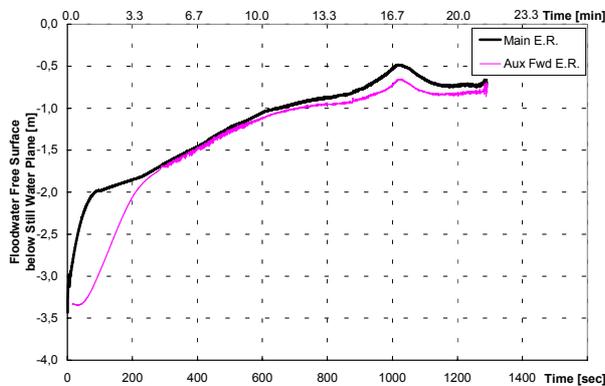
In Figure 13 the results of the simulation method for the vertical distance between the *floodwater free surface* at the main and the forward auxiliary engine rooms and *the still water sea surface* are presented¹³. This information is of particular importance, as these two compartments were the first flooded compartments in time sequence after the collision.

As observed in the above diagrams the floodwater is quickly pouring into the main engine room reducing the free surface distance from the still water plane by about one meter within the first minute. In later stages, the free surface level in this compartment gradually approaches the still water free surface while having a continuously lower level compared to the still water plane. This continuous difference in free surface levels indicates a continuous flooding through the damage opening 'A' and that there is a pressure head difference between the main and forward auxiliary engine room

Figure 13 Floodwater free surfaces at engine rooms with respect to the still water plane

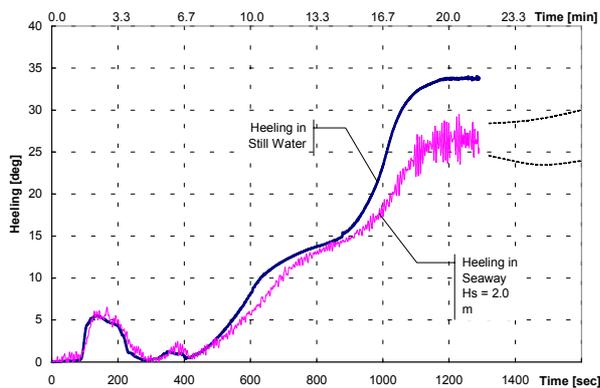
Figure 14 Heeling angle in calm and wavy sea

As observed in the above diagram, the history of the heeling angle in both cases is quite similar at least for the first quarter of hour after collision. The observed difference of about five degrees for the later stages of flooding increases the uncertainty of the predictions as the time passes beyond about 15 minutes. However, the simulated overall sinking process does not change and particularly the impact of sea waves on the crucial first stages of flooding is quite limited.

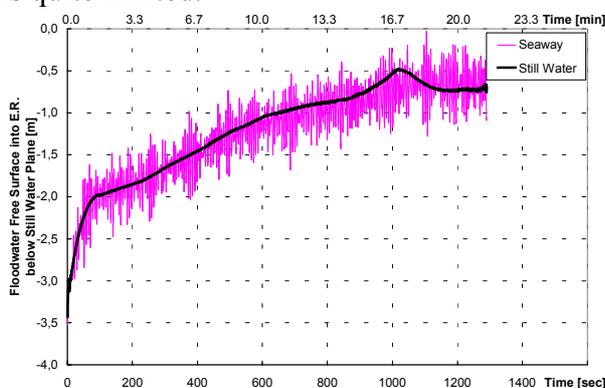
Figure 15 Floodwater free surface in the E.R.

In above Figure 15, the prediction of the floodwater level in the main engine room with respect to the still water surface is shown for the case of sea wave excitation, likewise the diagram of Figure 13 (calm water case). The floodwater level of the still water case seems to represent the mean value of the oscillatory level in case of flooding in waves.

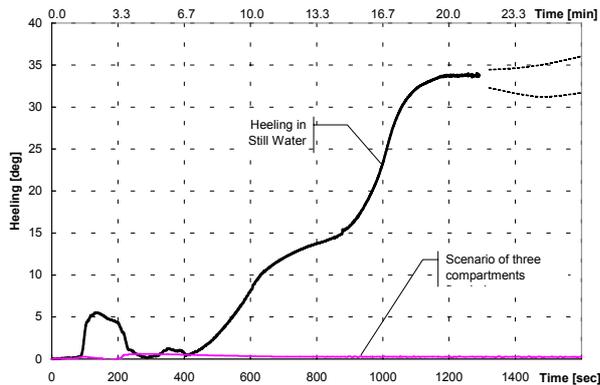
As shown by the simulation method, in this case the ship would remain continuously close to the upright position without any heeling. It would obtain in the final flooded-equilibrium condition a slight trim by bow and a margin line immersion at the fore part of the ship.

Figure 16 Ship heeling in case of only one open door (main to fwd aux. E.R.)

This heeling evolution, however, is clearly against the observations of the survivors and the final disastrous outcome of the investigated disaster; therefore this scenario can be certainly considered impossible. This scenario shows however that the ship even with these three damaged compartments flooded would have survived.

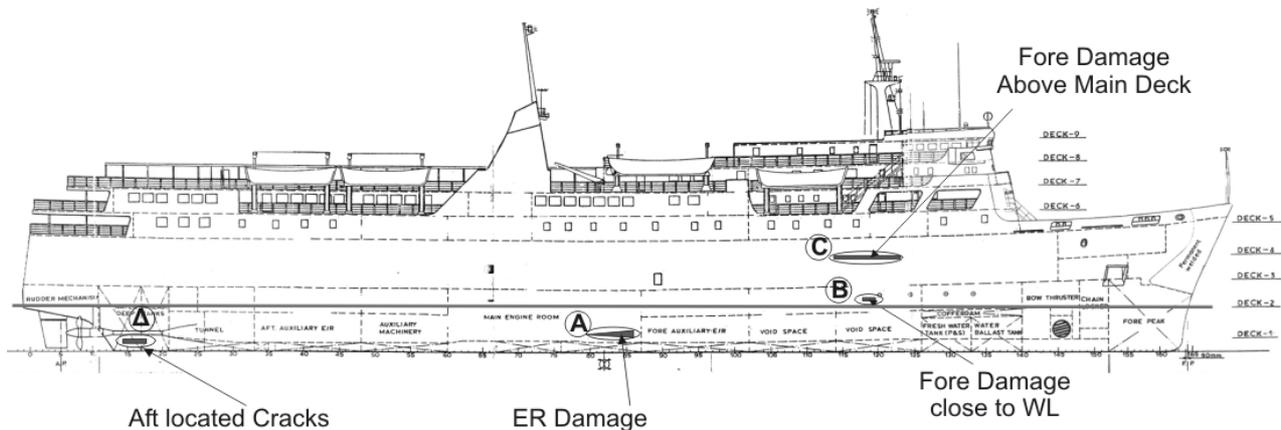
Figure 18 The reported damage openings

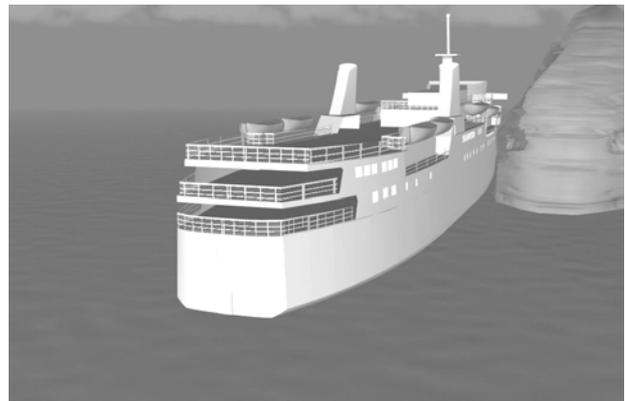
Following unsuccessful last moment maneuvers, the ship collides with the rocky islet, Figure 19, a few minutes before arrival to the destination port. Three damage openings

occurred on the starboard side of the vessel. The ship started immediately to be flooded by the lower damage, when the stabilizer fin penetrated the bilge area of the main engine room.

Figure 19 Ship collides with the rocky islet, time 0.

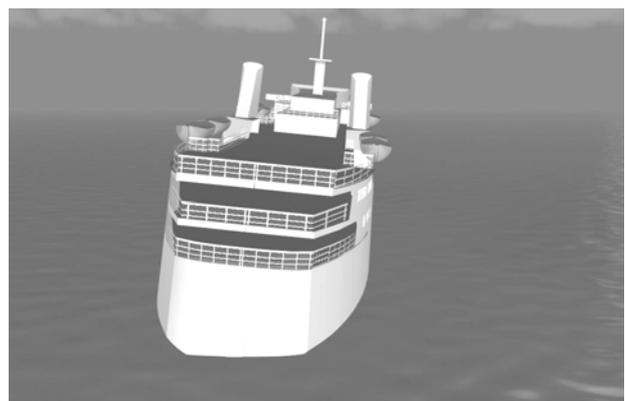
Shortly after the collision and within about 3 min the ship obtained a transient heeling of 5 degrees, as shown in the Figure 20. This immediate heeling was noted by the passengers. Later the ship returned back to the upright position in 5 min from the collision. The flooding mainly through the damage ‘A’ at the engine room continued.

Figure 20 Transient heeling of 5 deg, +3 min

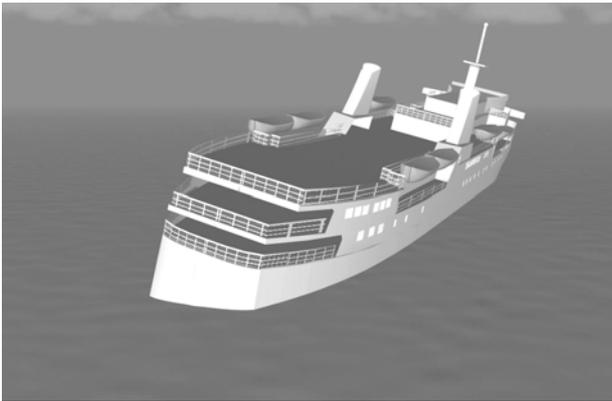
in the Figure 21. In this moment the larger damage 'C' at the height of platform deck immerses into sea water, while the backboard life boats could practically not anymore be launched.

Figure 21 Immersion of damage 'C', heel 14 deg, time +13 min

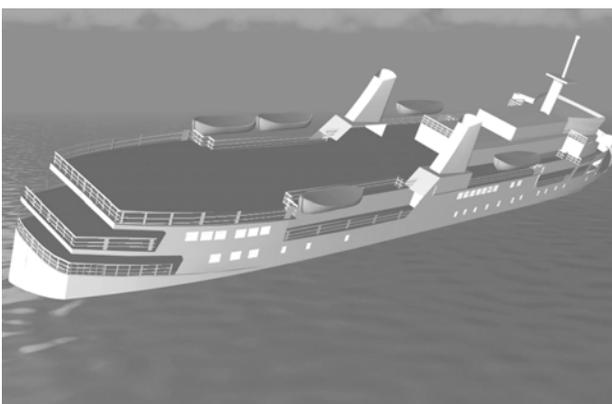
After the first 15 minutes and having the larger damage opening 'C' immersed the flooding process was speeded up. Soon the sea water level reached the promenade deck as shown in Figure 22. From this point on the superstructures started be flooded, the heeling continuously increased and clearly the ship has surpassed the point of no return.

Figure 22 Immersion of promenade deck, heel 23 deg, time +17 min

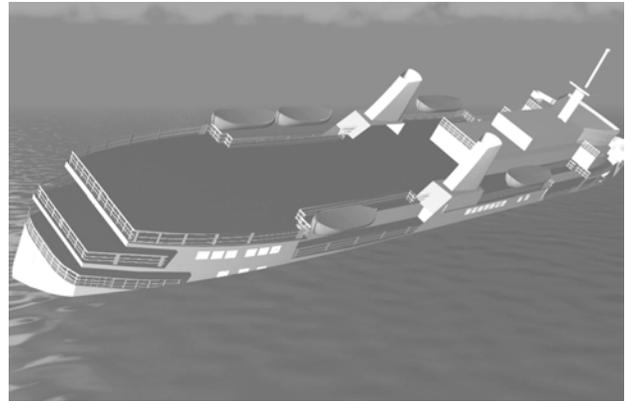
At twenty minutes after collision the seawater level reached the embarkation deck and the ship has obtained a large heeling angle of over 30 degrees, Figura 23. Walking on the ship is

Figure 23 Immersion of embarkation deck, heel 33 deg, time +20 min
