ANALYSIS OF THE CAPSIZE AND LOSS OF A 12000 DWT BULK CARRIER

Rumen Kishev, Bulgarian Ship Hydrodynamics Centre, r.kishev@bshc.bg
Vladimir Rakitin, Bulgarian Ship Hydrodynamics Centre, v.rakitin@bshc.bg
Silvia Kirilova, Bulgarian Ship Hydrodynamics Centre, s.kirilova@bshc.bg

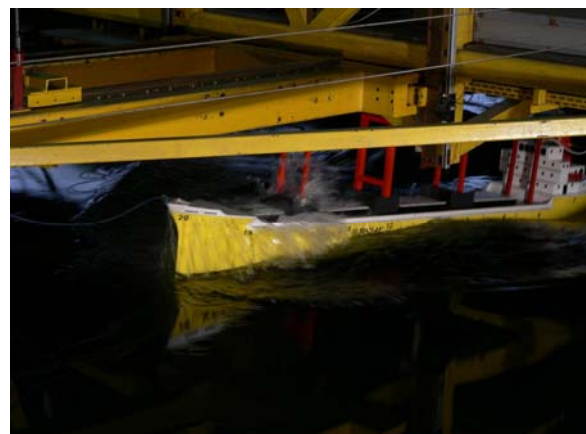
The results obtained show that motion parameters are within expected limits, the differences between three loading conditions being minor. However, at adverse headings (as was the case of forced storming after closing of the strait), the deck wetness intensity is very high – even at speed reduced down to 6 kn at Bf6 (H1/3 = 6 m), the number of deck wetness occurrence for loading case CH1 is about $N_{dw} = 50$, while good marine practice allows 30. This means that the bow part and the hatch cover of Hold № 1 in particular had been subjected to intensive loading by overwhelming waves. For loading cases CH2 and CH3 this intensity increases 1.5 – 2 times, due to effective freeboard decrease after flooding of the bow compartments.

Figure 2. Illustration of intensive deck wetness at head seas.

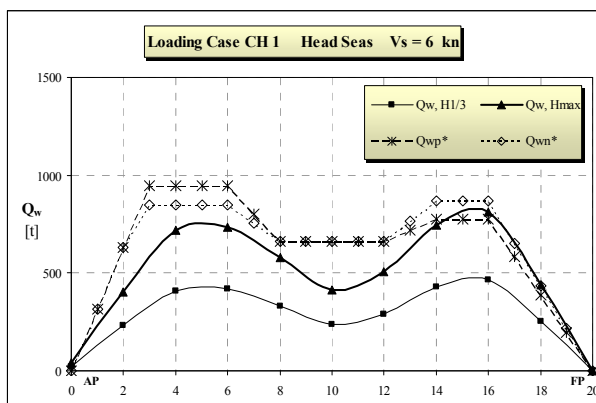
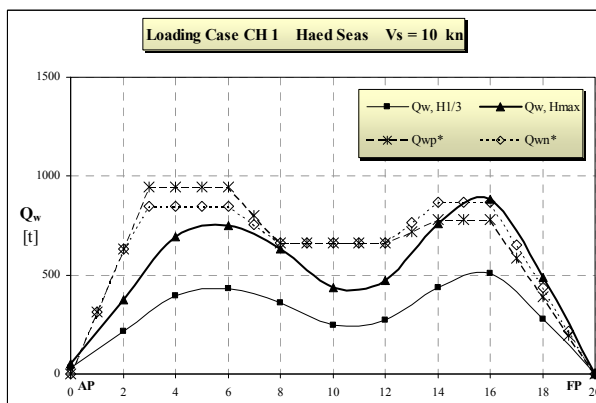
Figure 3. Shearing forces along the ship length as compared to the IACS allowable values.

It is well seen, that in head seas the resulting shear forces at the bow, in vicinity of Hold № 1, exceed the maximum allowable values in case of chancing over a wave larger than the statistically average one. It means that at the time of taking adverse course to waves in heavy storm, the occurrence of structural damage at the bow or dislocation of the hatchcover was highly probable.

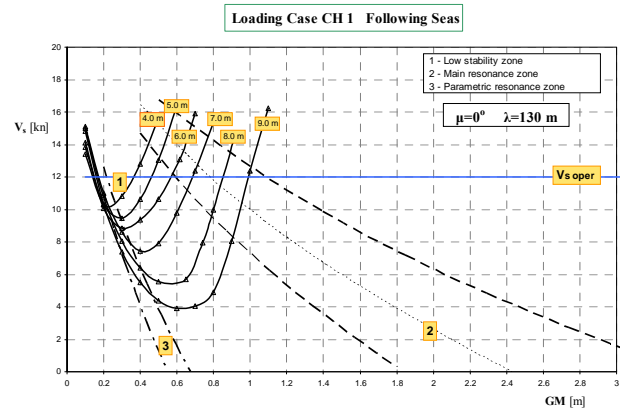
Figure 4. Diagram of endangered stability in following seas for the intact ship.

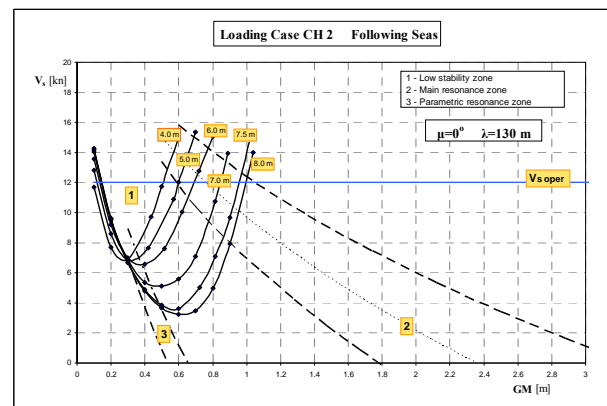
The diagrams for the safe operation in following seas for the three loading conditions are shown in Figs. 4 – 6. It can be seen that when sailing with heel and trim and taking into account the newly formed free surfaces in the partially flooded cargo holds, the vessel falls into an unfavorable zone which endangers her

operational stability. More specifically, at significant wave heights over 5 m, after the instance of water penetrating the holds and forming free surface the ship becomes unstable.

Figure 5. Diagram of endangered stability in following seas for the damaged ship – Hold № 1 flooded, static heel 9°, 1.30 m trim to bow.

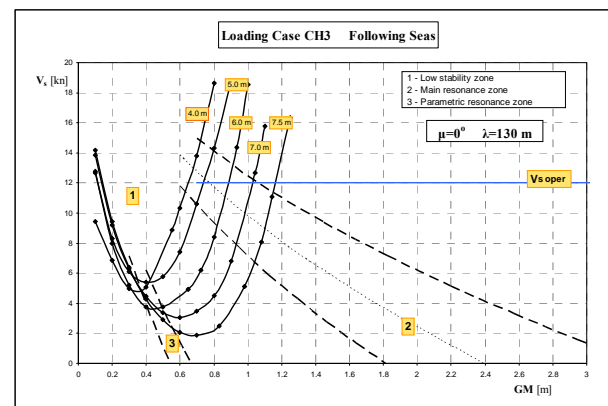
Figure 6. Diagram of endangered stability in following seas for the damaged ship – Hold № 1 and forepeak flooded, static heel 9°, 2.45 m trim to bow.

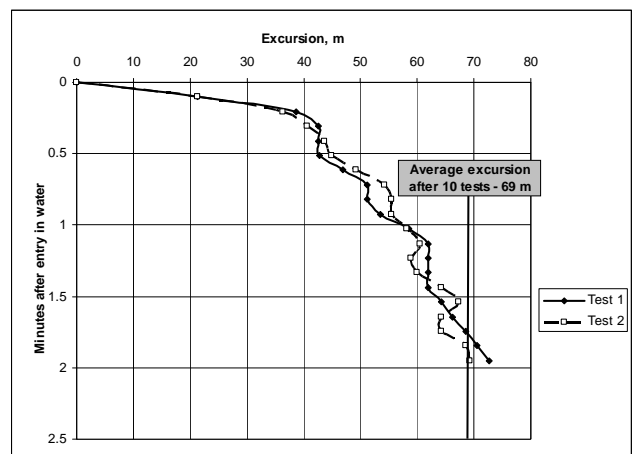
Figure 8. Falling trajectory of the hatchcover of Hold № 1 in case of entering into water with the edge ahead.

Based on the test results it can be stated that the hatchcover’s fastening dogs have been loosed in advance, maybe by green water chancing on deck during storm ride, and the shock of collision with the ground at the moment of sinking provoked final disengagement.
