Use of the Wolfson stability guidance for appraising the operational stability of small fishing vessels

Matteo Scarponi, *Wolfson Unit MTIA, University of Southampton*, M.Scarponi@soton.ac.uk

Keywords: *Stability, Safety, Wolfson Guidance, Stability Notice, Freeboard Mark.*

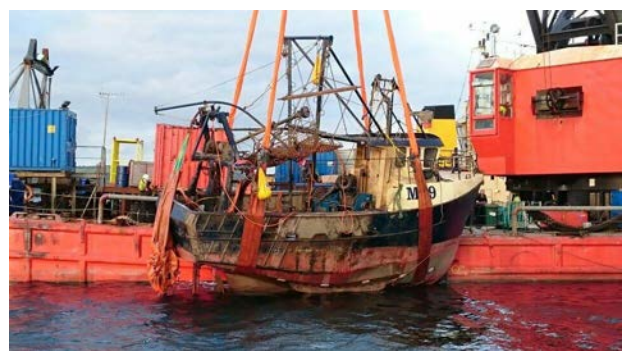
Figure 1 – Salvaged wreck of F/V JMT (Credit: MAIB)

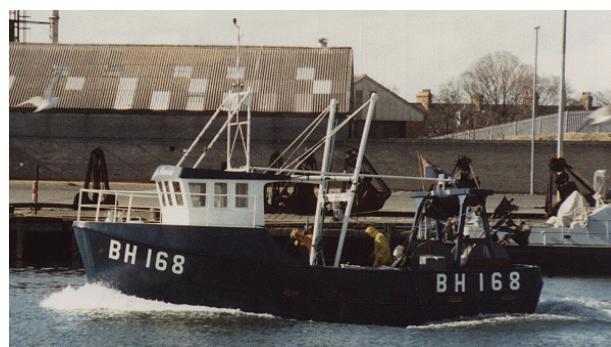
Figure 2 – Lady Patricia (Credit: trawlerpictures.net)

JMT (previously Lady Patricia) was built in 1988 as a conventional stern trawler and was fitted with a forward wheelhouse, amidships ‘scotch poles’ and a stern gantry (Figure 2). Between 2003 and 2013 the vessel’s stern gantry was raised and a port side shelterdeck was added. Subsequently, the vessel was converted for scallop dredging, which involved fitting winches and outriggers for handling the scallop gear, removing the shelter deck, raising the stern gantry further and replacing the scotch poles with a goalpost gantry. The latter vessel configuration (Figure 3) was approved by Seafish Marine Survey in 2013 and, subsequently, by the MCA.

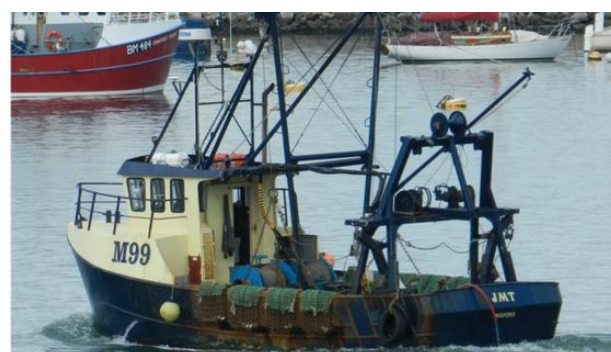
Figure 3 – JMT following 2013 conversion (Credit: trawlerpictures.net)

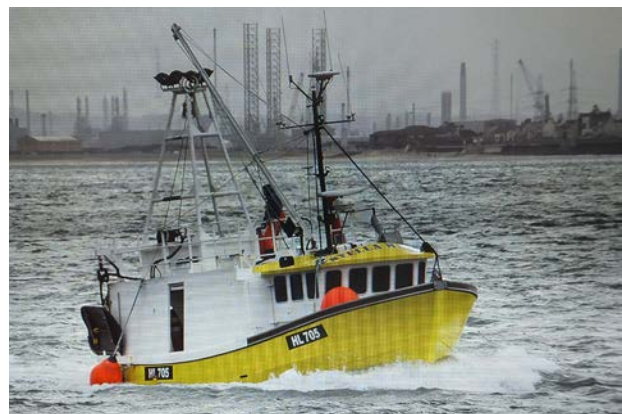
Stella Maris was built in 1999 as a conventional stern trawler. Initially, it was equipped with a gilson derrick for performing cod end lifts over the side and releasing the catch on deck. In 2013 it underwent major modifications, see Figure 5, to enable lifting over the stern into a catch hopper, thus improving the quality of the catch. To that effect, the gilson derrick was removed and a stern gantry was fitted, which raised the lifting point by approximately 1m. Also, the cod end had to be raised by approximately 1.65m above the bulwark to clear the upper edge of the hopper, so it could be emptied in the hopper from an overhead position. The catch would then remain in the hopper and gradually feeding to the sorting area beneath the shelterdeck.

Figure 5 – Stella Maris following 2013 modification (Credit: Jon Irwin)
