Investigation of the Intact Stability Accident of the Multipurpose Vessel MS ROSEBURG

Adele Lübcke, *Institute of Ship Design and Ship Safety, Hamburg University of Technology*

German Federal Bureau of Maritime Casualty Investigation (Hamburg)

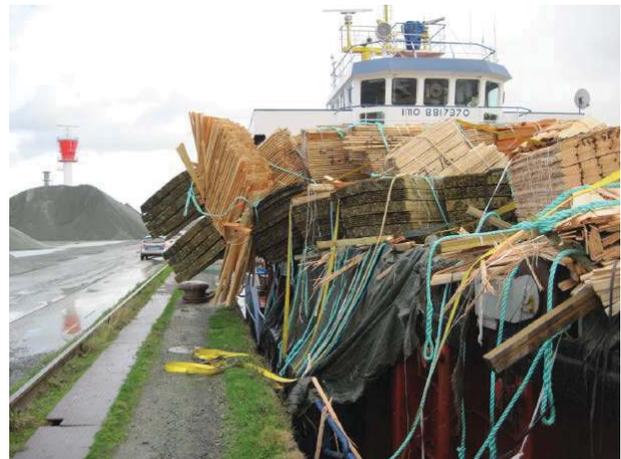
Figure 1 Consequences of the accident

At five o'clock the captain asked for the permission of anchoring to perform small repairs. Shortly afterwards the ship began to heel and reached a heeling angle of 10 to 15 degree caused by a gust of wind. As a result of the heeling angle and the related accelerations the timber cargo on deck slipped and the load securing failed. Hence the ship reached a heeling angle of 40 degree and the

main part of timber cargo on deck went overboard. Following the stability of MS ROSEBURG was increased and the vessel reached a stable position of equilibrium. In Figure 1 the consequences of the accident are shown. People were not injured in the accident.

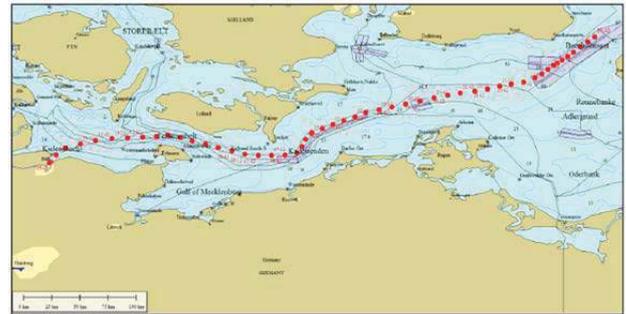
Figure 4 AIS Data of MS ROSEBURG

On the second of November 2013 MS ROSEBURG was laden with timber cargo and cable reels and left the port of Riga at 20.00 o'clock. The destination of the voyage was the harbour of Barrow Haven, UK. On the fifth of November 2013, the vessel reached the Bay of Kiel where the accident occurred. The track of the vessel is displayed in figure 4.

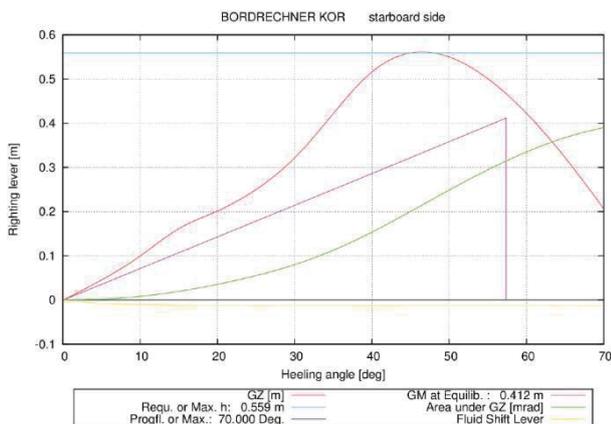
Figure 6 Lever arm curve during the departure time with corrected centre of gravity

Therefore, a new calculation is performed with a corrected centre of gravity for the load of the timber cargo on deck. It is assumed that the mass of the cargo is 1845 t in the hold and 300 t on deck. This corresponds to the loading condition of comparison from the stability booklet. As a result the initial stability of the ship is reduced from 0.891 m to 0.412 m, also the lever arm for greater heeling angles. In figure 6 the lever arm curve with a corrected centre of gravity is presented. In this case MS ROSEBURG do not comply the applicable intact stability criteria.

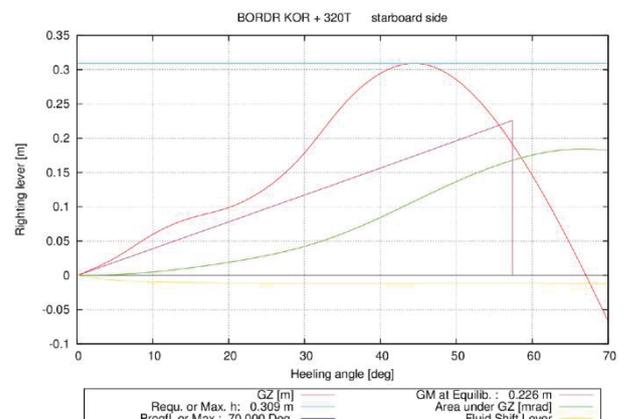
Figure 9 Lever arm curve at departure time in Riga with corrected centre of gravity and cargo load

Following from the previous considerations the cargo on deck was not correctly declared regarding the mass and the centre of gravity in the printout of the on board computer. Hence the loading condition at departure time is corrected in accordance to the previous investigations. This loading condition is considered to be the most likely loading condition at departure time in Riga. In figure 9 the corrected lever arm curve is presented.

The corrections take into account the centre of gravity of the timber cargo on deck and the missing mass. The additional deck cargo is estimated with 320 t. This value is calculated from the difference between the information s of the timber cargo from the on board computer and the shipping company. The centre of gravity is assumed with the value of the loading condition of comparison of the stability booklet.

In consideration of this the deadweight is determined to 3206 t in the loading condition on departure from Riga. Thus the maximum value of 3005 t is exceeded. Furthermore the intact stability criteria are not complied.
