INVESTIGATION INTO THE SINKING OF THE RO-RO PASSENGER FERRY *EXPRESS SAMINA*

A. Papanikolaou, D. Spanos, E. Boulougouris, E. Eliopoulou, A. Alissafaki
National Technical University of Athens-Ship Design Laboratory, NTUA-SDL, (Greece)

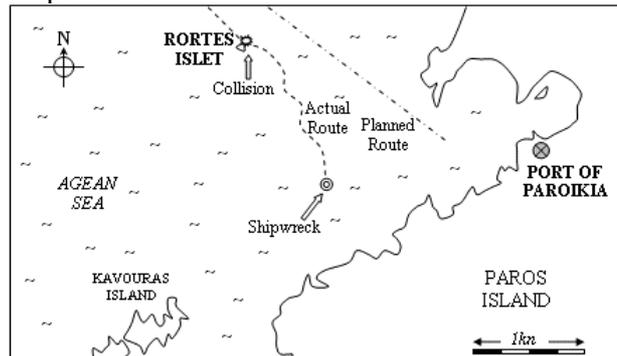
Figure 1 Map of the accident area

operating for a prolonged time on autopilot went off course and hit the *Portes* islet at about 22:12, despite some last moment maneuvers by the bridge officer on duty to avoid the disastrous collision. Figure 1 shows a sketch of the planned and actual route, the location of collision, the destination port and the shipwreck.

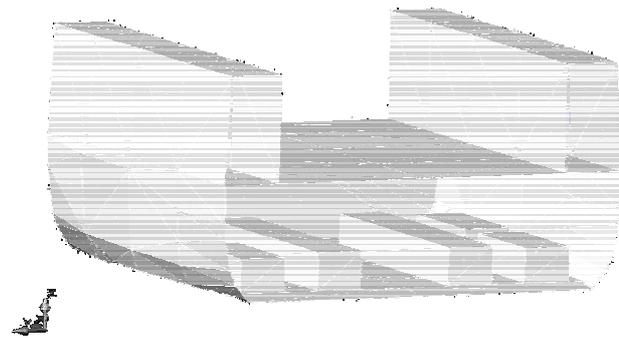
Figure 12 Geometric modelling of main engine room including car deck side casings

according to SOLAS regulations. The modeling of the main engine room was more carefully pursued, so that the space occupied by the main and auxiliary machineries could be considered (see Figure 12 below).
