# Experimental investigation on one damaged passenger ship in regular and irregular beam waves

The motion and the internal water height of one passenger ship in intact and damaged state are investigated experimentally. The experimental methodology is introduced in detail. The effect of the damaged opening's size and the quality of the simulated wave are examined carefully before the formal case study. The time history of the intact and damaged ship motion in regular and irregular beam waves are presented and compared to the numerical predictions. Results indicate that the roll amplitude of the damaged ship is smaller than that of the intact one under the testing damaged conditions, but it doesn't mean a safer circumstance for the damaged ship due to the existence of the constant heeling angle. The numerical prediction of the ship motion in regular and irregular waves match the experimental results with certain accuracy, calling for further modifications to the flooding model.

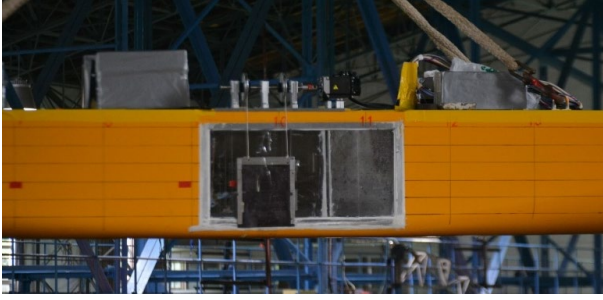
To examine the influence of the damaged opening's size, two rectangular openings are investigated in the experiment, which are formed instantaneously by a self-designed windlass-rope-plate mechanism, as showed in Figure 3. The damaged opening locates at the position with 125 mm offset from the port and 8 mm offset from the bottom side. Two openings differ only in the height, i.e. 143 mm for O1 and 70 mm for O2, which stands for cross-waterline damage and under-waterline damage, respectively.

Figure 3: Self-designed electrically operated valve for controlling the opening's size.

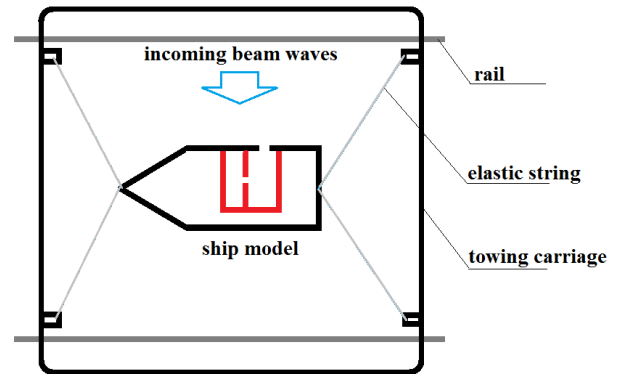
The experiments are carried out in the seakeeping basin of China Ship Scientific Research Center (CSSRC). Several elastic strings tied the ship model to the towing carriage to constrain ship's drifting, as presented in Figure 5. The existence of the springs should not alter the first resonance frequency of the system, which means the natural

period of the spring should be more than 10 times of that of the ship model.

Figure 5: The sketch of the experimental arrangement (the damaged cabin is marked in red)
